D3.3

Case studies – Issue 3

Instrument	Collaborative Project
Call / Topic	H2020-SEC-2016-2017/H2020-SEC-2016-2017-1
Project Title	Multi-Hazard Cooperative Management Tool for Data Exchange, Response Planning and Scenario Building
Project Number	740689
Project Acronym	HEIMDALL
Project Start Date	01/05/2017
Project Duration	42 months
Contributing WP	WP 3
Dissemination Level	PU
Contractual Delivery Date	M26
Actual Delivery Date	07/08/2019
Editor	Jordi Vendrell (PCF)
Contributors	David Martín, Sebastien Lahaye, Felipe Borderas, Oriol Vilalta (PCF), Daniel Milla, Laia Estivill, Edgar Nebot, Jordi Pagès (INT), Flavio Pignone (CIMA), Bruce Farquharson (SFRS), Sefik Muhic, Jesper Bachmann Marcussen (FBBR)

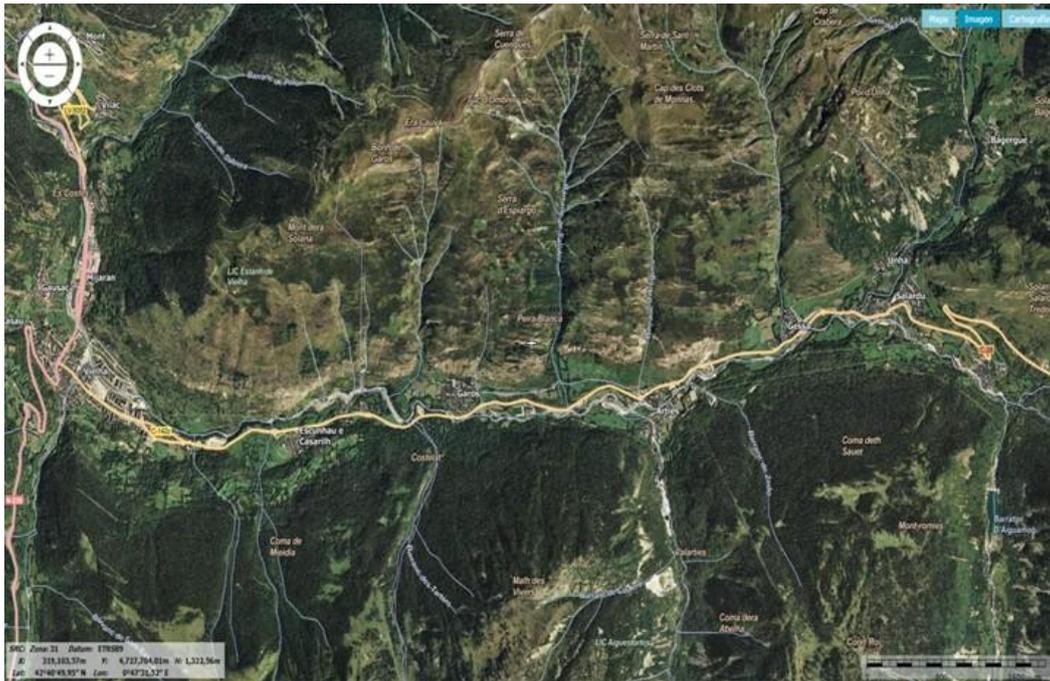
Figure 3-1. Ortophoto of the study area.

The cartographic data that is presented below provides information on the location of the study area (Figure 3-1), land-uses (Figure 3-2), topography (Figure 3-3), geology (Figure 3-4), hydrogeological characteristics (Figure 3-5), and erodibility of the terrain (Figure 3-6).

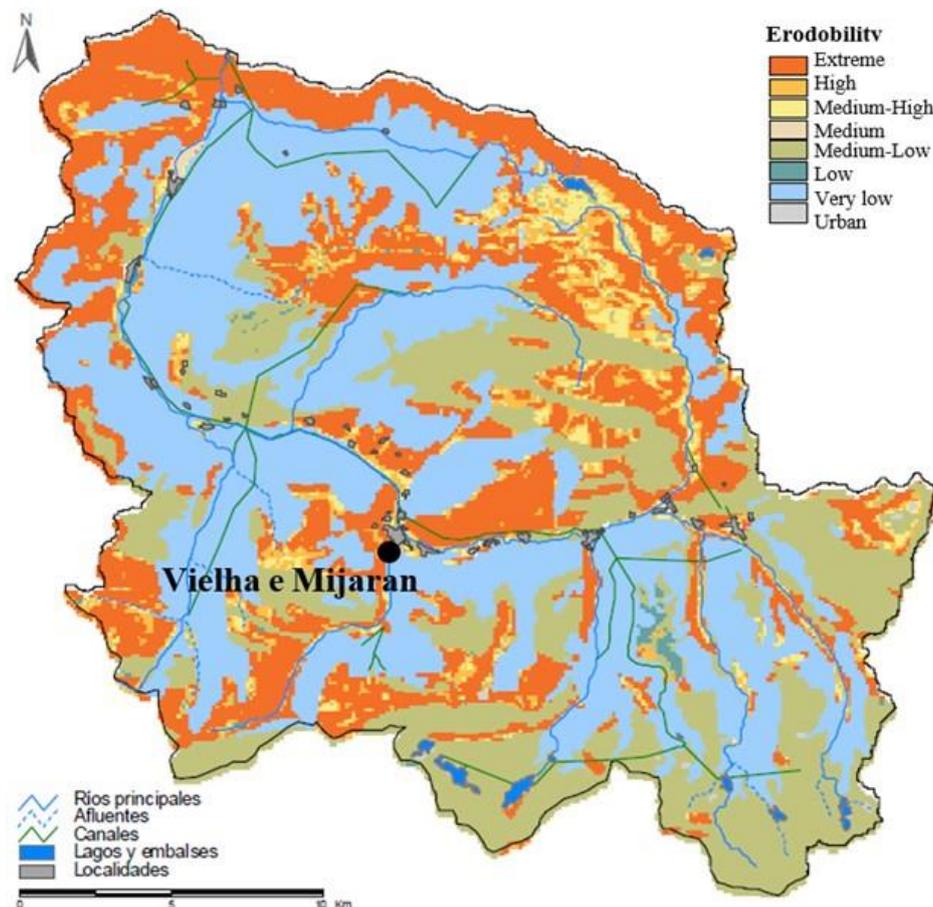
Figure 3-6. Erodibility map of the study area.

The floods were not the only risk affecting the area. The copious rainfall triggered other hazardous event in a cascade effect; namely, landslides, torrential mass movements (especially debris flows) and an increase in the alluvial fan activity (see Figure 3-22). The geological characteristics of the terrain and the soil, in combination with the power of rainfall, had influence on the occurrence of these events [7]. The cascading effect had a greater impact on areas with high erodibility (see Figure 3-6).

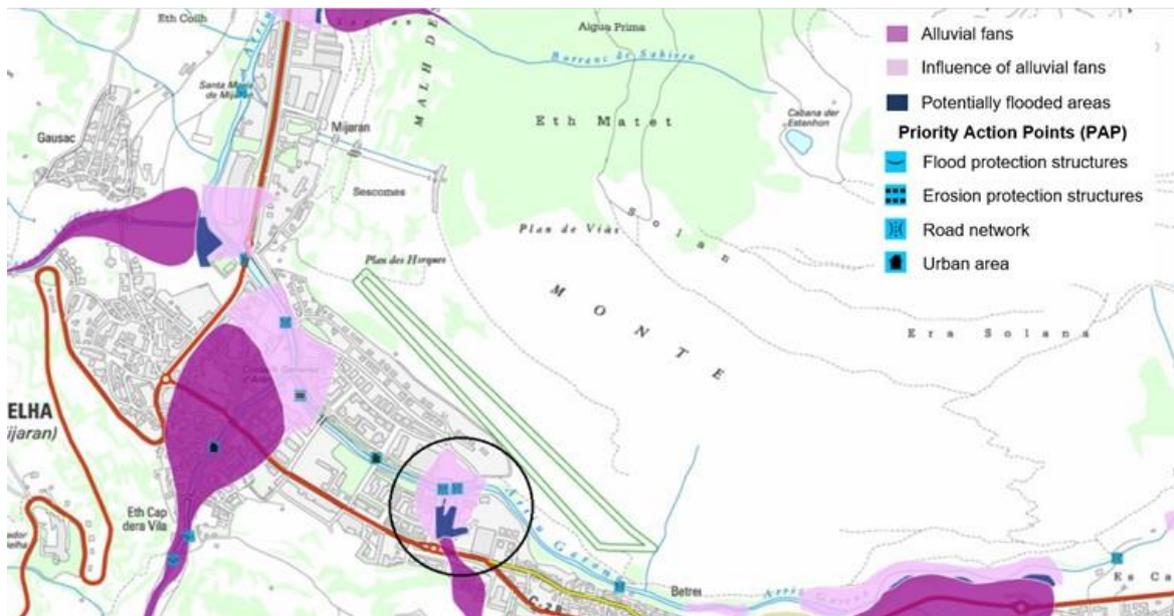
Figure 3-23. Map of flood impacts on an industrial area.

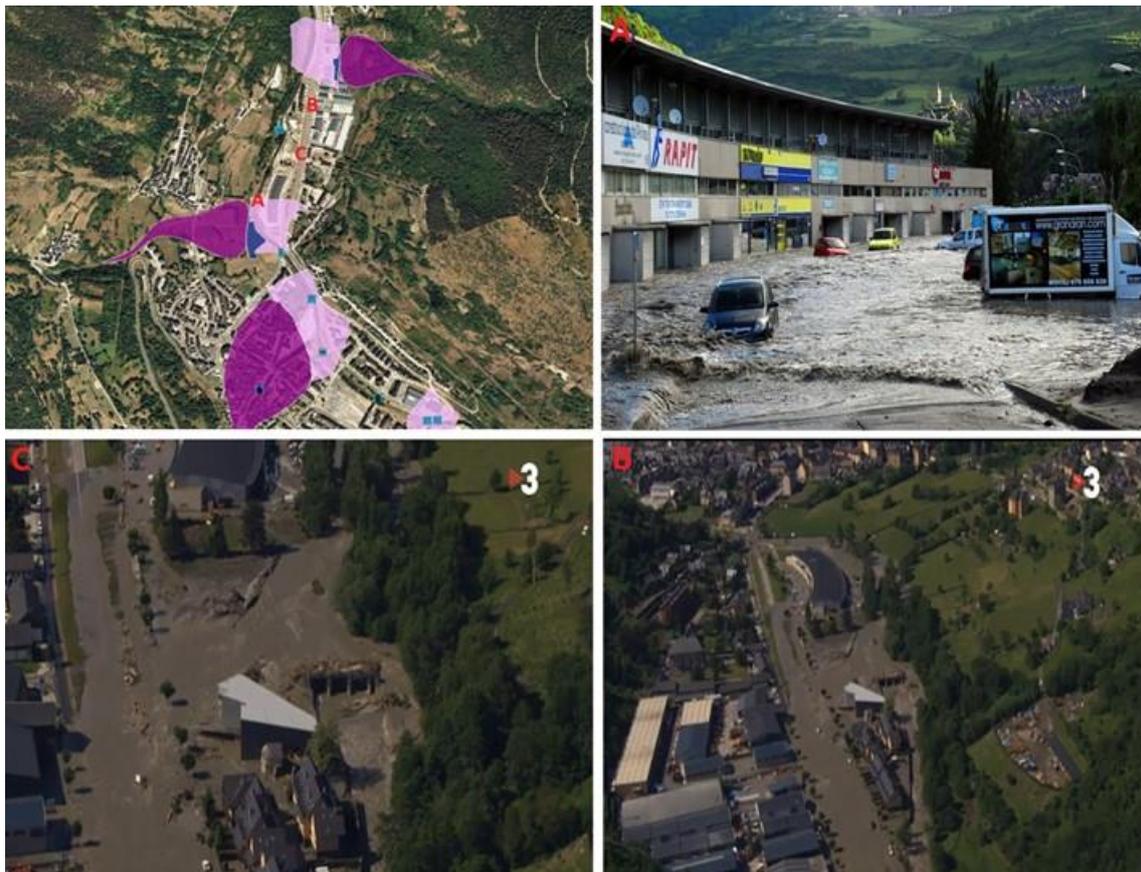
Figure 3-24. Image of flood impacts on an industrial area.

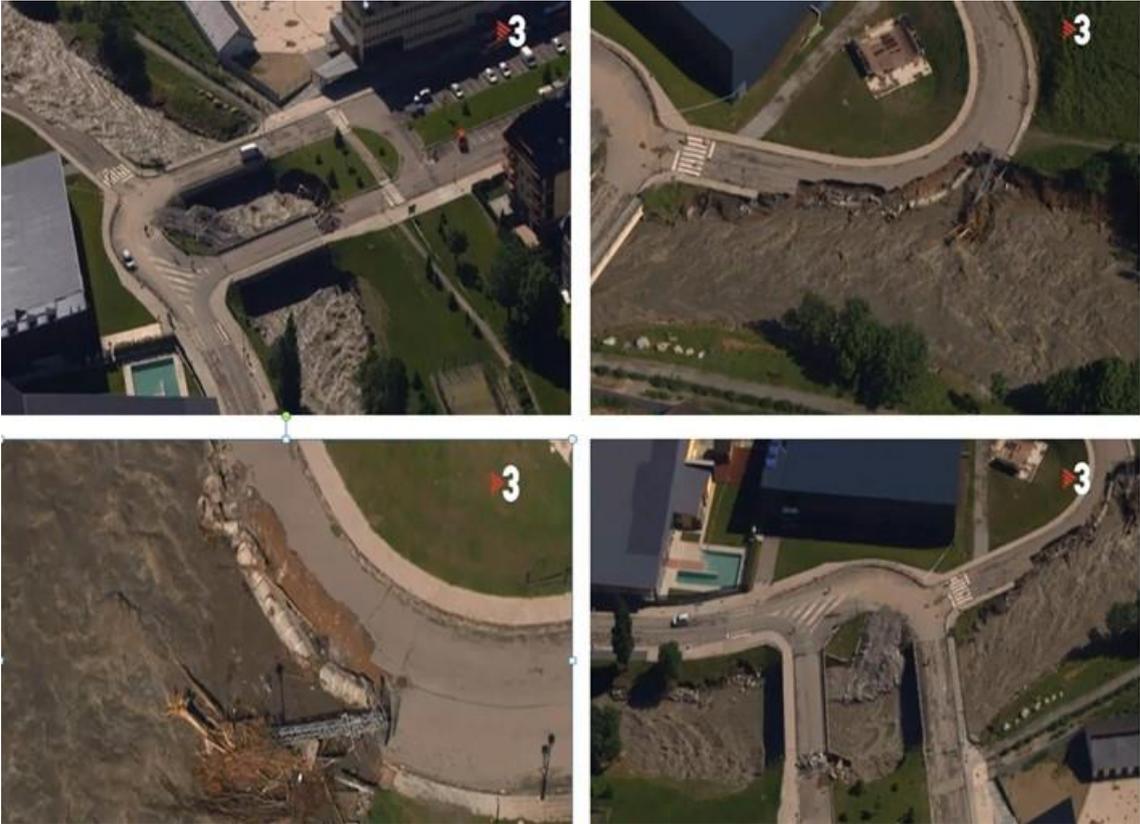
Figure 3-26. Image of flood impacts on a school area.

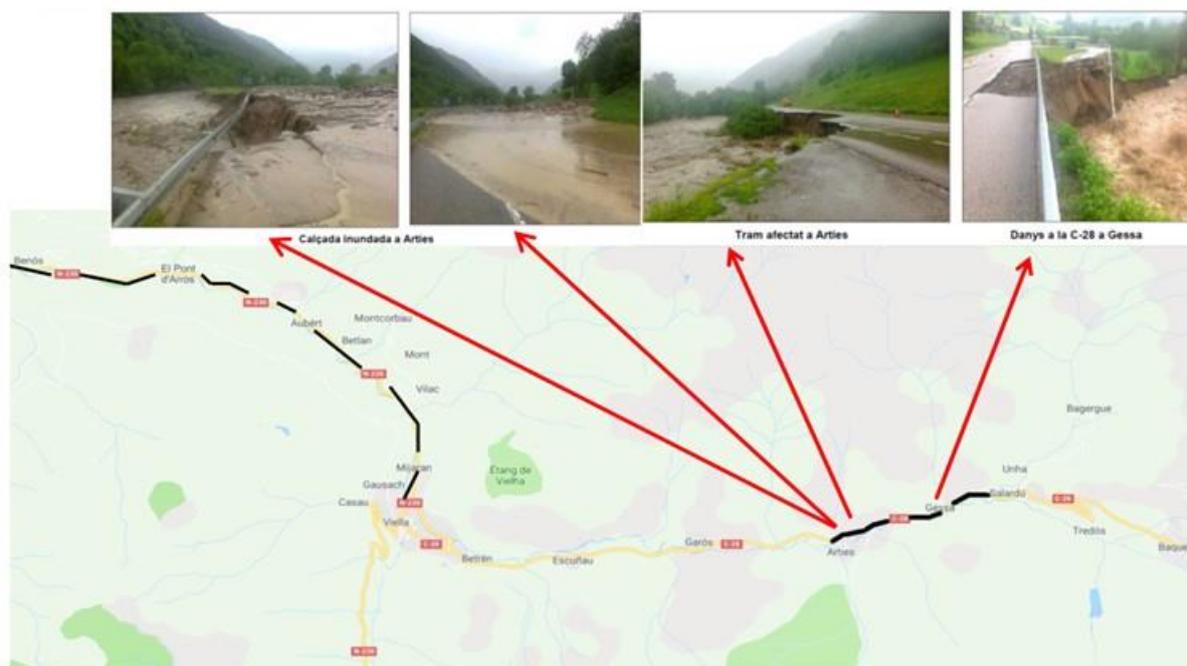
Figure 3-28. Map and images of flood impacts on the road network.

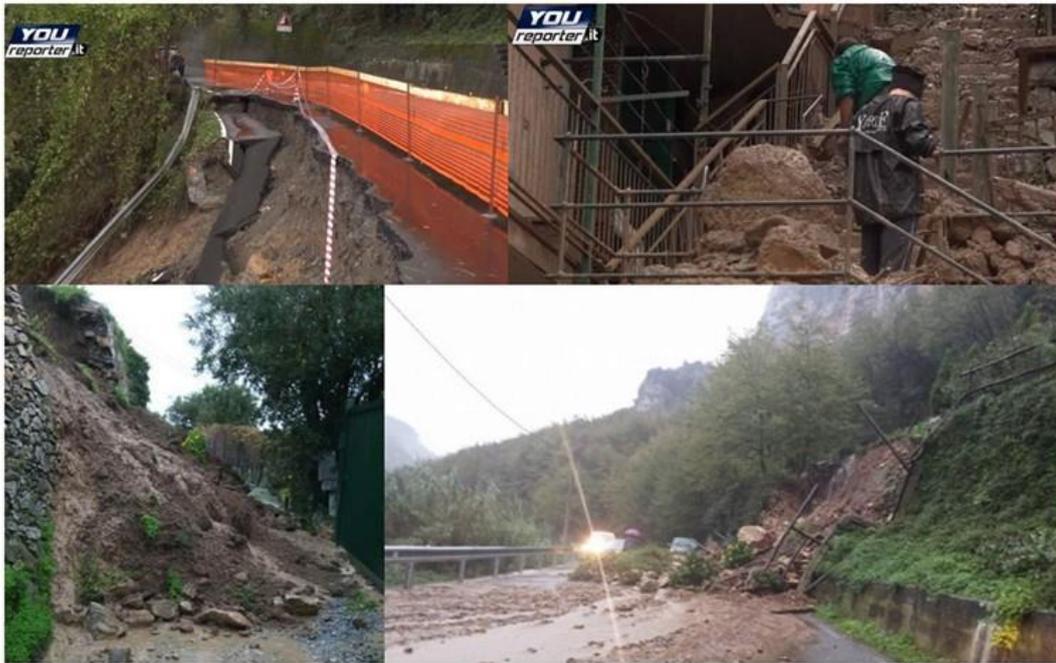
Figure 4-23. Images of landslides during the Tigullio floods.

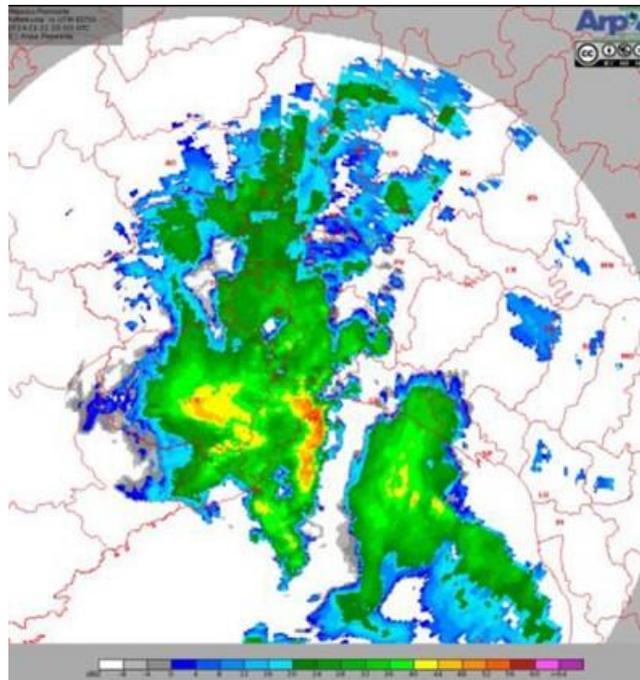
Figure 4-31. Reflectivity map on the 11th of November 2014 at 10:00h UTC. The structure of the thunderstorm with southwest northeast axis is displayed in red-orange colour.

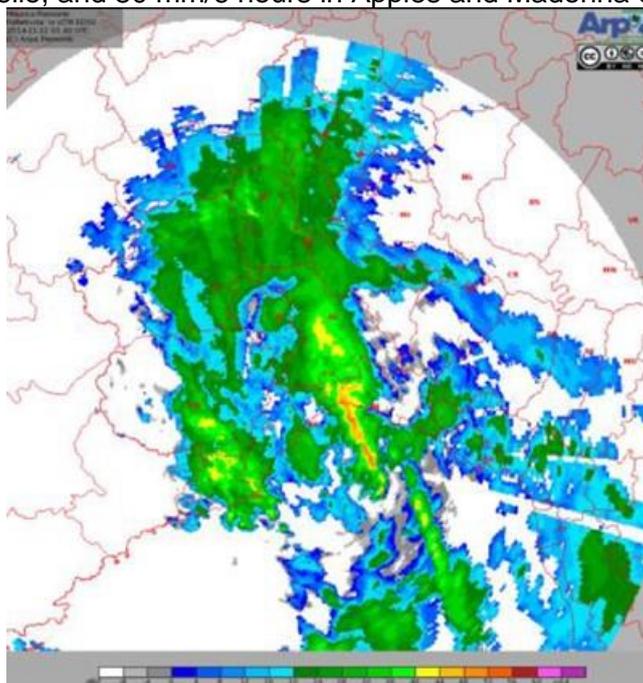
Figure 4-32. Reflectivity map on the 12th of November 2014 at 01:40h UTC. The structure of the thunderstorm with southwest northeast axis is displayed in red-orange colour.

In the early hours of the 12th of November, rainfalls resumed abundantly across the area of Genoa area, being particularly intense in the west. A band of precipitation with a southeast-northwest axis initially involved the city centre and then move towards the west (Figure 4-32), where it gave rise to heavy and long-lasting showers that recorded high accumulations of water: 117 mm/6 hours in Genoa-Pegli, 100mm/6 hours in Sanctuary Monte Gazzo, 90mm/6 hours in Monte Pennello, and 80 mm/6 hours in Apples and Madonna delle Grazie about.

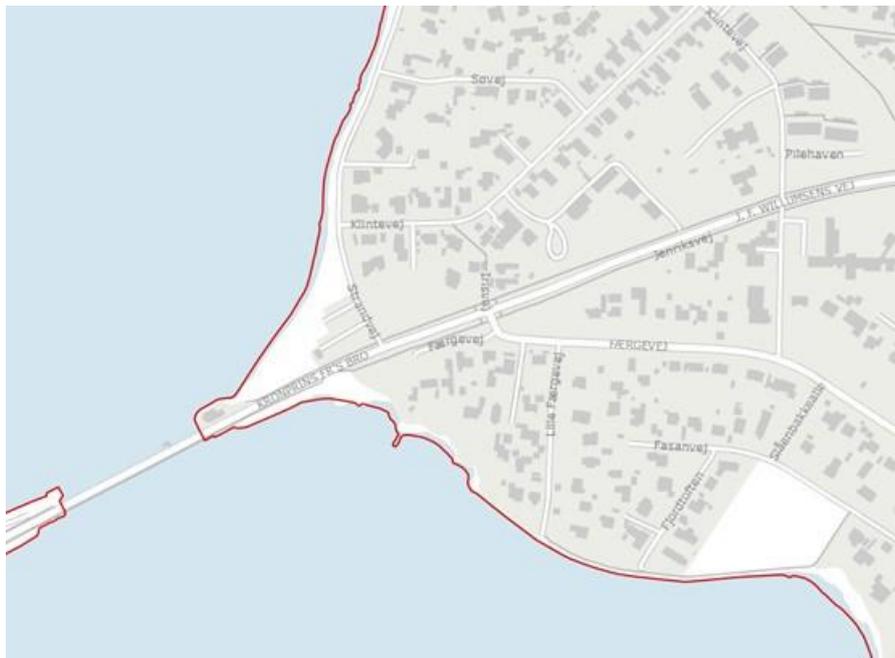
Figure 6-1. Coastal area (harbour) in the municipality of Frederikssund Municipality.

This study case is based on a flood incident that started on the 29th of October 2017 at 11:28 am (Danish Emergency Management Agency's [DEMA] statistical bank: www.odin.dk) in a coastal area within the FBBR Frederikssund Municipality (Figure 6-1). It is one of FBBR's representative scenarios related to climate change in cooperation with the Risk Based Dimensioning (RBD), which is part of the Comprehensive Preparedness Planning (CPP). A detailed analysis of this scenario has been made and is included in the FBBR RBB-plan 2019 (www.fbbr.dk).

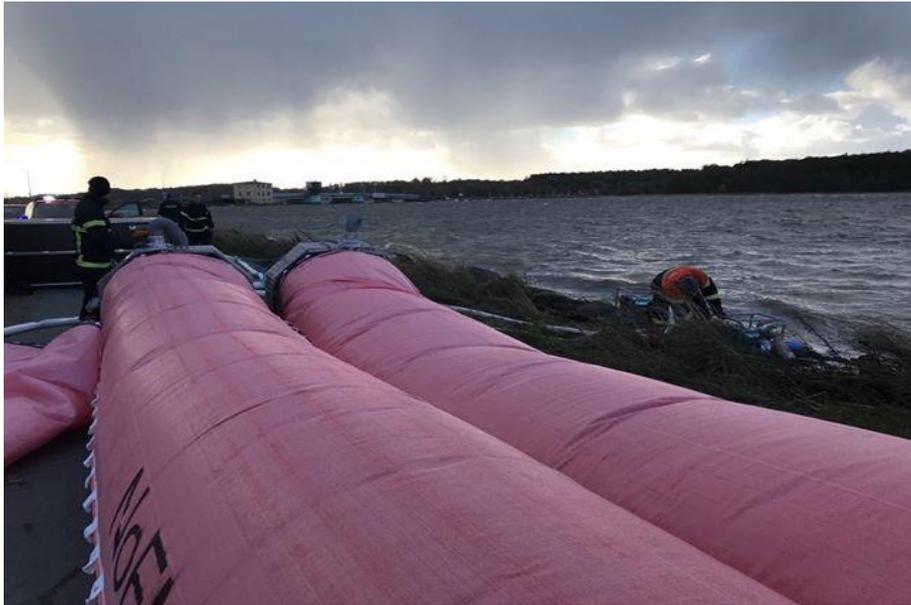
Figure 6-2. Flood protection measures – installation of the water tubes (1/2).

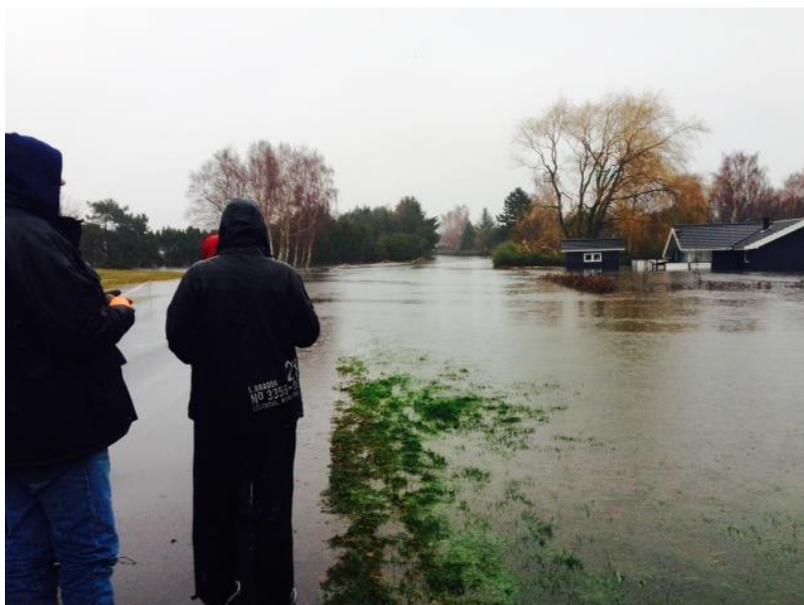
Figure 6-4. Flooded area in the municipality of Frederikssund during the flood events in 2017.

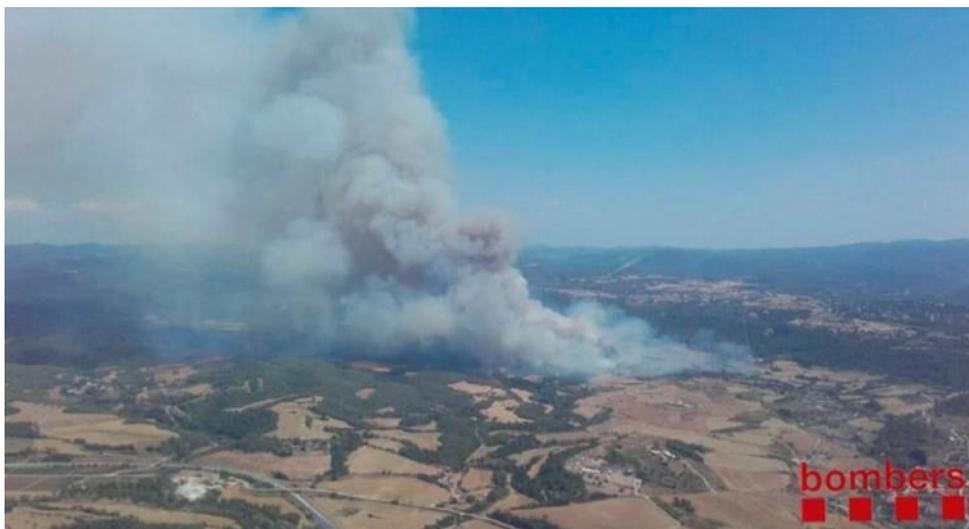
Figure 7-1. Aerial image of Artés fire.

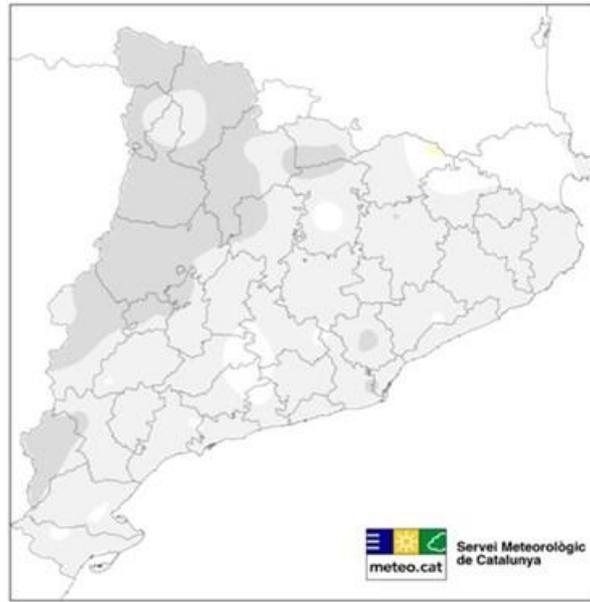
Figure 7-10. Monthly solar irradiation anomaly (%).

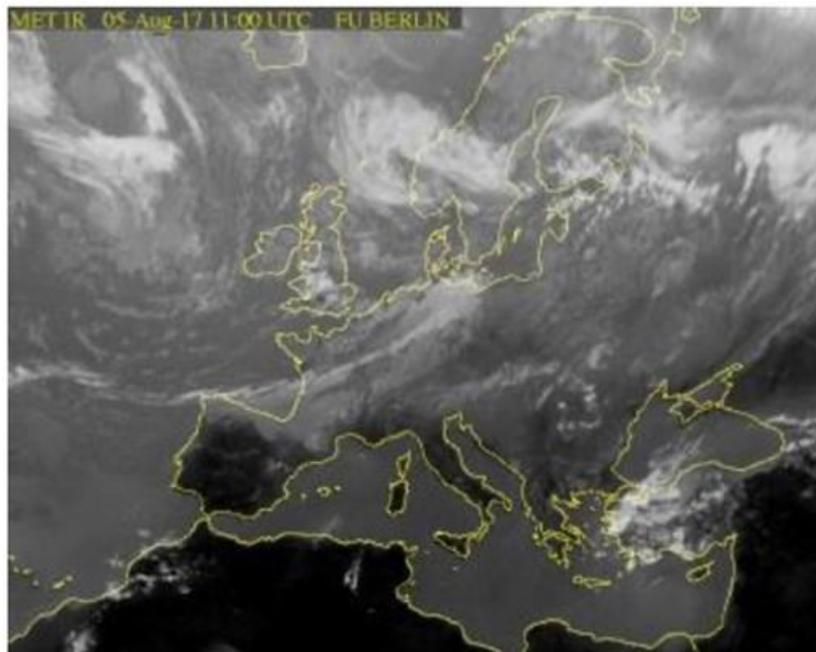
Figure 7-13. METEOSAT image for the 5th of August at 12:00h UTC.

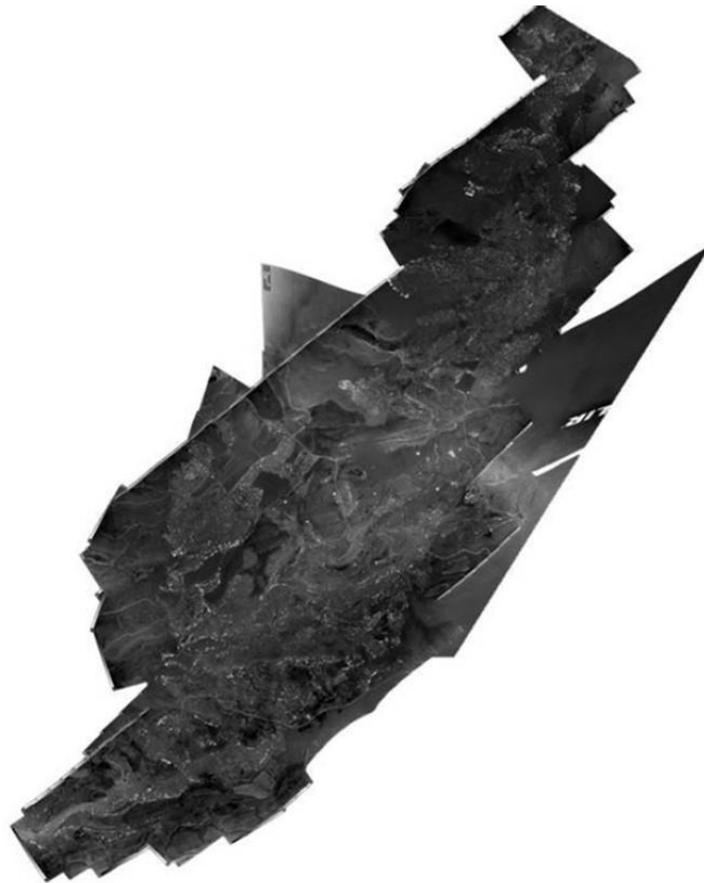
Figure 7-17. Perimeter of the fire made up of drones images obtained during the drone flight during the night on the 5th of August 2017 for the location of hotspots.

During the first night the firefighters tested a drone that was provided by the MAPAMA (Ministry of Agriculture, Fisheries and Food of the Spanish Government) to track the hot spots and capture a set of aerial images that allowed them to make a better assessment of the development of fire. All the data obtained from the drones was geo-referenced and transferred into a GIS system for a more detailed analysis on the fire situation. Early next morning that information became very useful for the management of aerial firefighting resources and the definition of priority points to perform the fire suppression actions.

The information provided by the drones (Figure 7-17) was used in combination with the field observations made by the ground personnel to have a complete picture of the fire perimeter, including both the contour and the area inside [5].

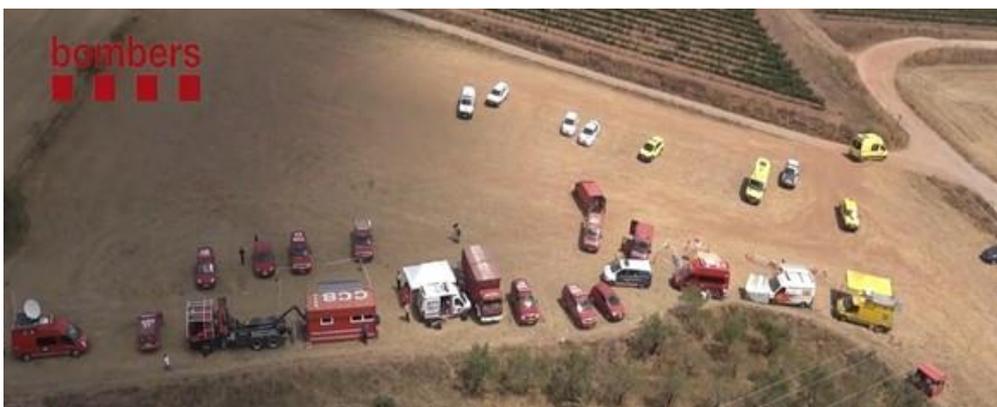
Figure 7-23. Point of Transit in Artés fire.

- Accompany other emergency services who are less familiar with the area so they can act faster, and be more efficient.
- Request reinforcements to the local police of *Sant Fruitós de Bages*.
- Provide refugee locations and support/help for evacuees.
- Traffic control.
- Call for solidarity asking resident population for help in distributing water and food to emergency services, as well as firefighting activities (firewalls) under the leadership of firefighters and ADF.
- Maintain checkpoints at the accesses to the fire area.
- Support firefighters and ADF agents in their tasks.
- Traffic control.
- Perimeter surveillance.
- Surveillance of the area affected to protect the assets (particularly houses) in the area.
- Assistance in the transportation of people and means from and to the "point of transit" (Figure 7-23).

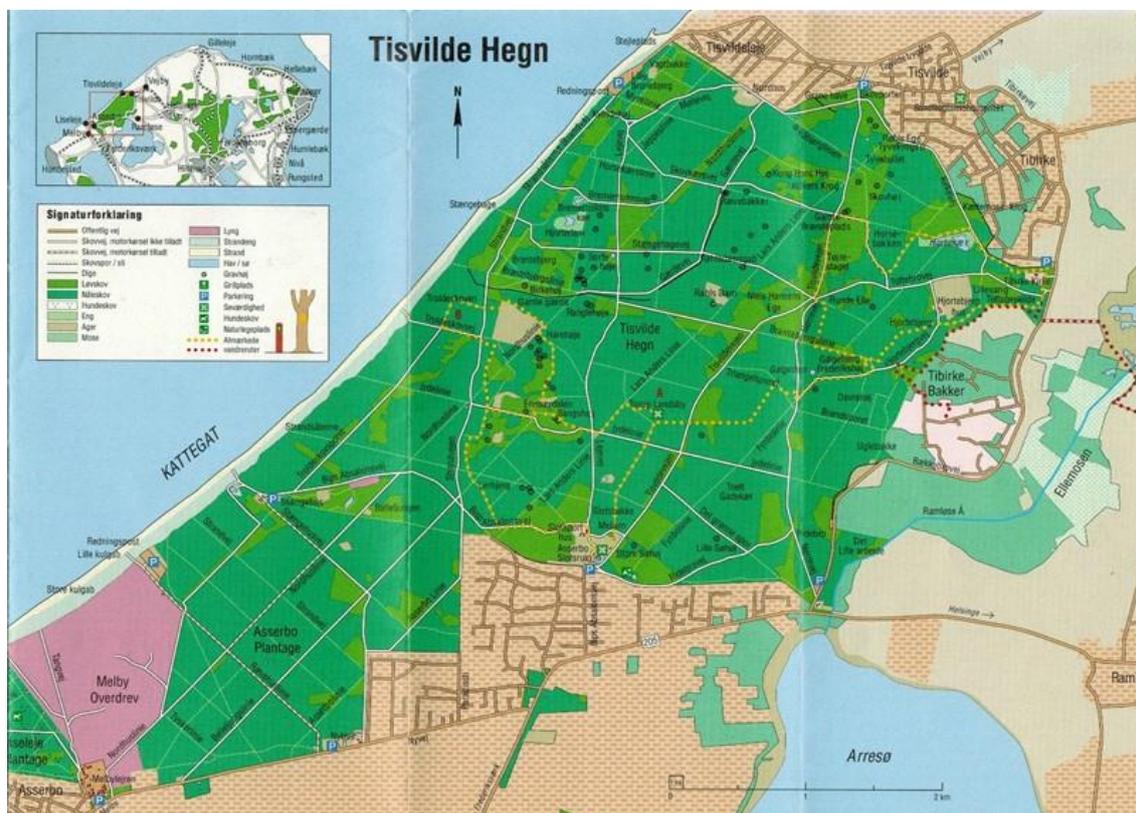
Figure 8-1. Forest area in Tisvilde Hegn.

The forests of Tisvilde Hegn (Figure 8-1) consist of a big pine plantation covering about 1,400 ha in the northern coast of Zealand island, in Denmark. Tisvilde Hegn is part of the European Natura 2000 network as it contains rare and valuable habitats, protected by the EU Habitats Directive, as well as plants, animals, and an important birdlife that is protected by the EU Birds Directive. The area is dominated by pine forest and open pine forest, also including scattered beech and oak. The birch has managed to dominate sites where conifers have been felled without being re-seeded. The popular Troldeskov grows, along the coastal shore on dune hills, are formed by ancient 200-year-old pine trees heavily growth-inhibited, low and distorted, due to the harsh wind. The forest is essentially the nature of a true mid-Scandinavian coniferous forest, which (as well as the area's close location to Sweden) has provided a breeding ground for a unique collection of animals and plants that otherwise are not found in the rest of Denmark. The variegated collection of landscapes in the Tisvilde area, including heath and high bogs, heathlands, heather heaths, overgrowth, meadow swamps, large sun-exposed open hills, sandy surfaces and dunes, have also made it possible for many rare species, linked to a wide range of different habitats, to establish a solid foothold in the area (www.naturstyrelsen.dk).

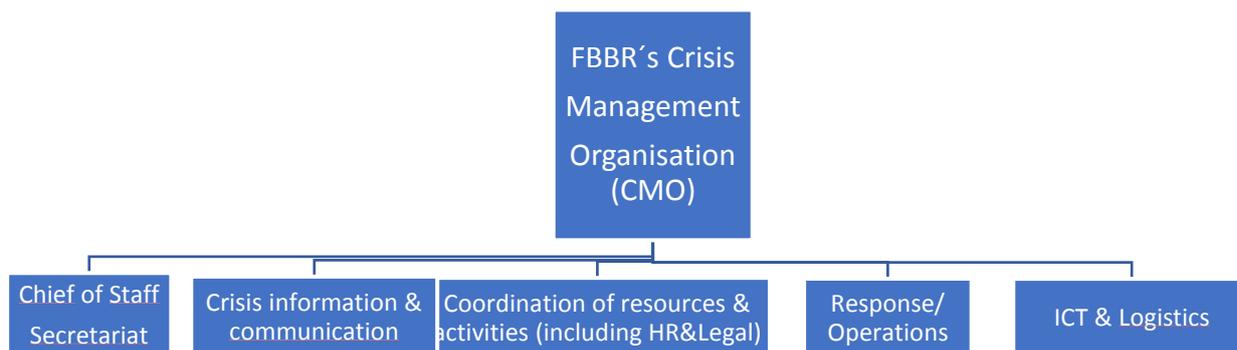
Figure 8-2. Crisis management in Denmark at municipal/FBBR level.

Decision-making structure and organization management is shown in Figure 8-2.

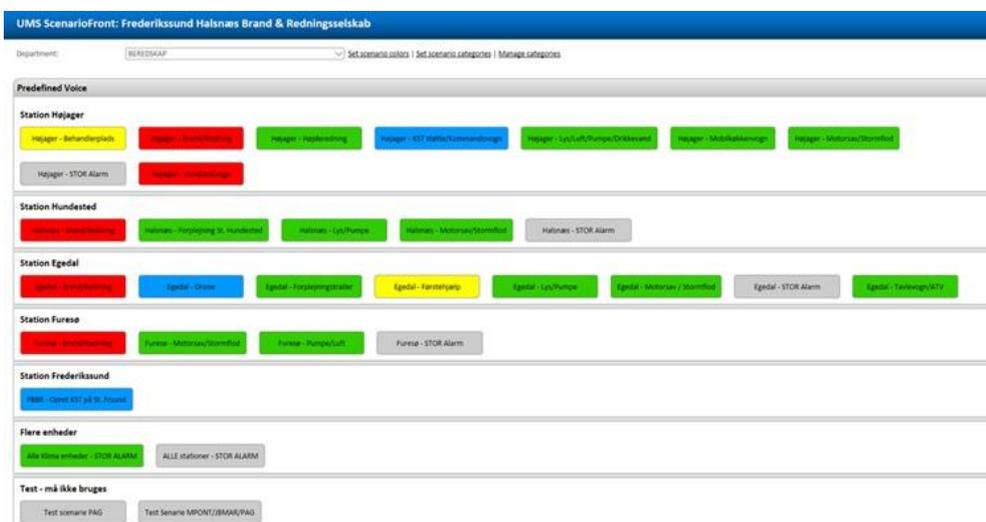
Figure 8-3. Example of UMS – Module to turn on the alarm for volunteers.

- **UMS (Unified Messaging Systems) module.** To avoid confusion with other SMS (mobile phone text message) templates, FBBR has made SMS Preparedness as a separate module that can handle a given emergency situation immediately and effectively. When you open the module to turn on alarm, the entire screen turns red to alert you that everyone (Figure 8-3)– from the established list - gets your message.

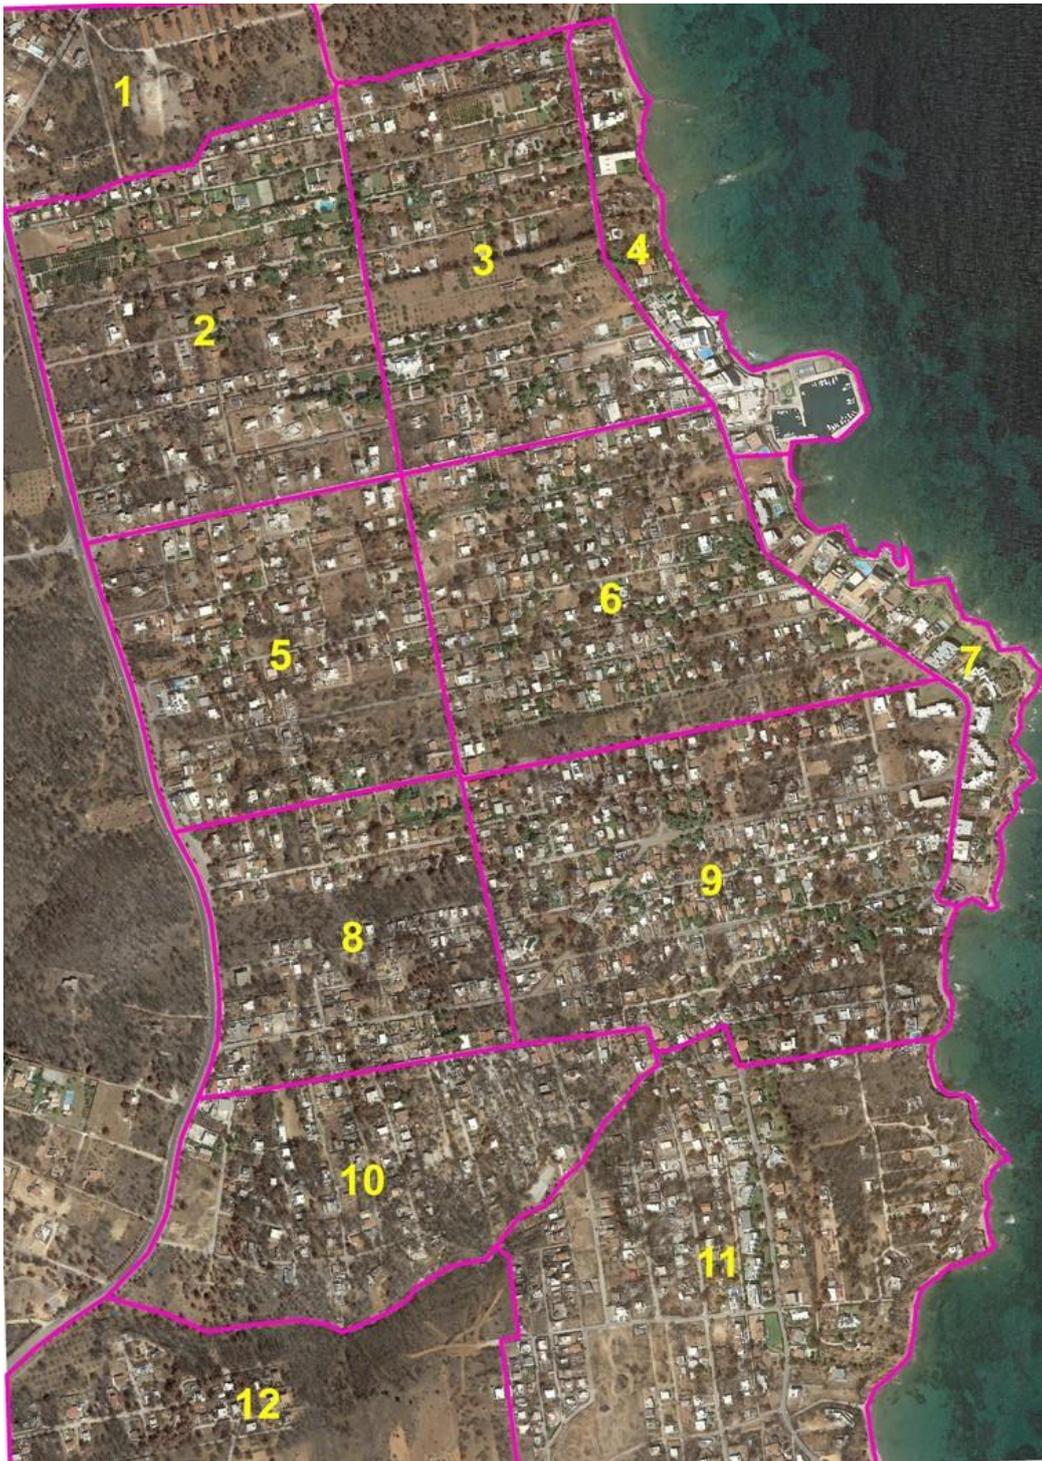
Figure 9-2. Sectors used in Mati area to help in the systematic survey for structure loss assessment.

- For some of the zones, a set of sectors were established to facilitate a systematic survey. In particular, in Mati area 12 sectors were described (Figure 9-2), mainly using streets as separators. A 6-digit naming convention was used (ZSSHHH) to label the structures, where Z is a letter addressing the zone, SS is the sector and HHH the number of house within the sector. Each house was then identified in the orthophoto, the map and the existing photos in the database.

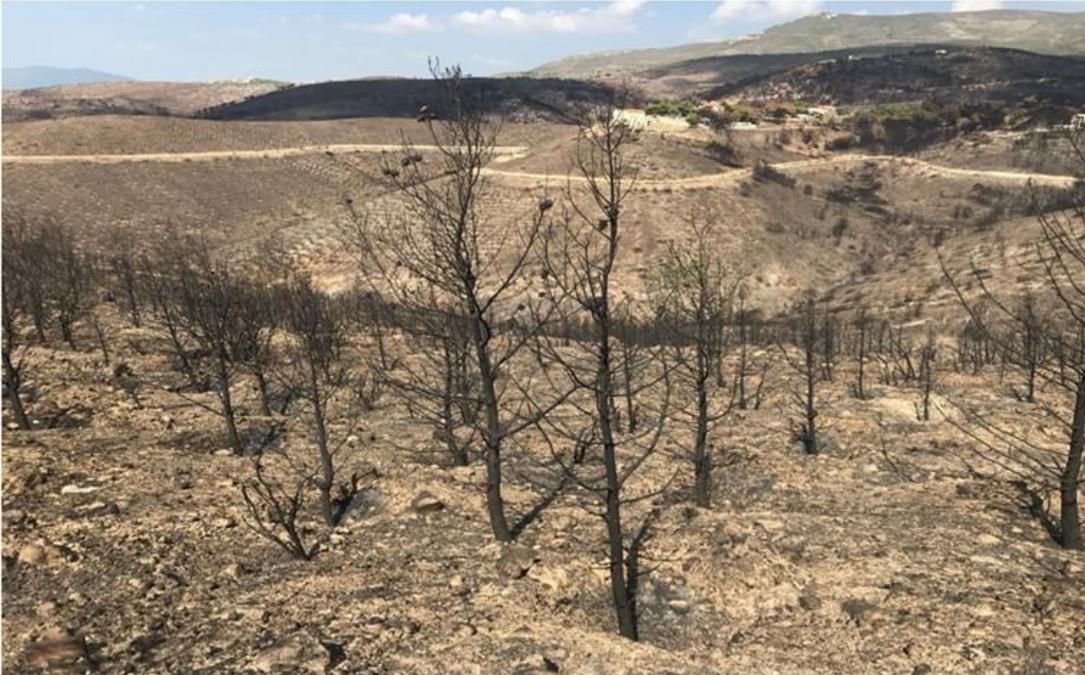
Figure 9-3. First run of the fire front. The first run took place over a young pine stand. In the background (looking towards West) the Pantokrator Monastery and Daou Penteli, the origin of the fire.

The head of the fire encountered several patches of young pine stands along the way (Figure 9-3), which were part of the reforestation works done after the 2005 wildfire to recover the

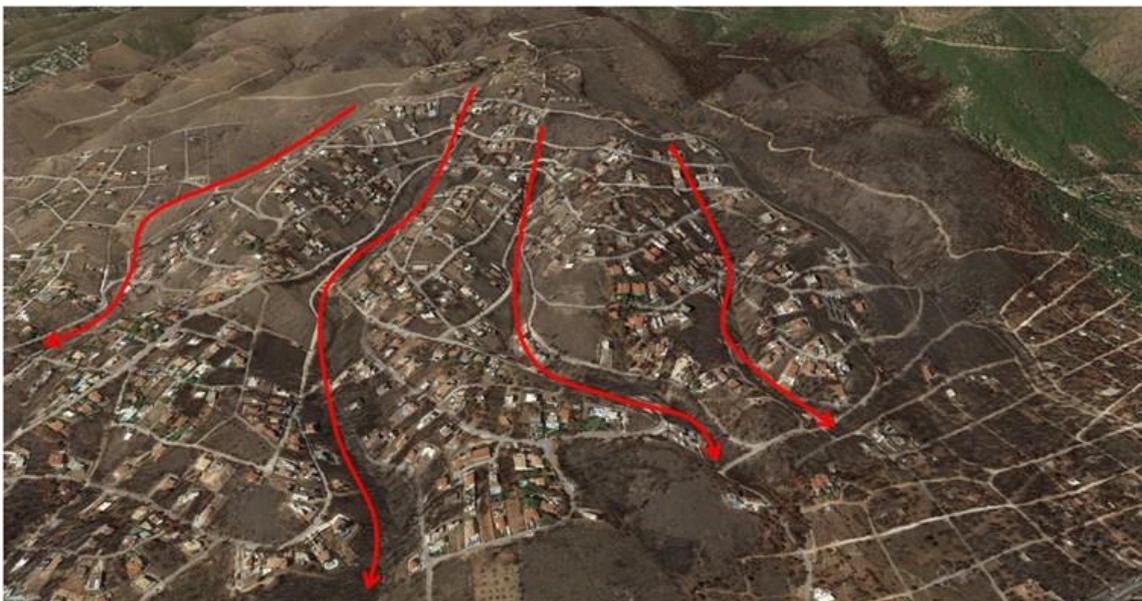
Figure 9-4. Interpreted main fire runs through ravines within Neos Voutzas settlement, following the main wind component (West).

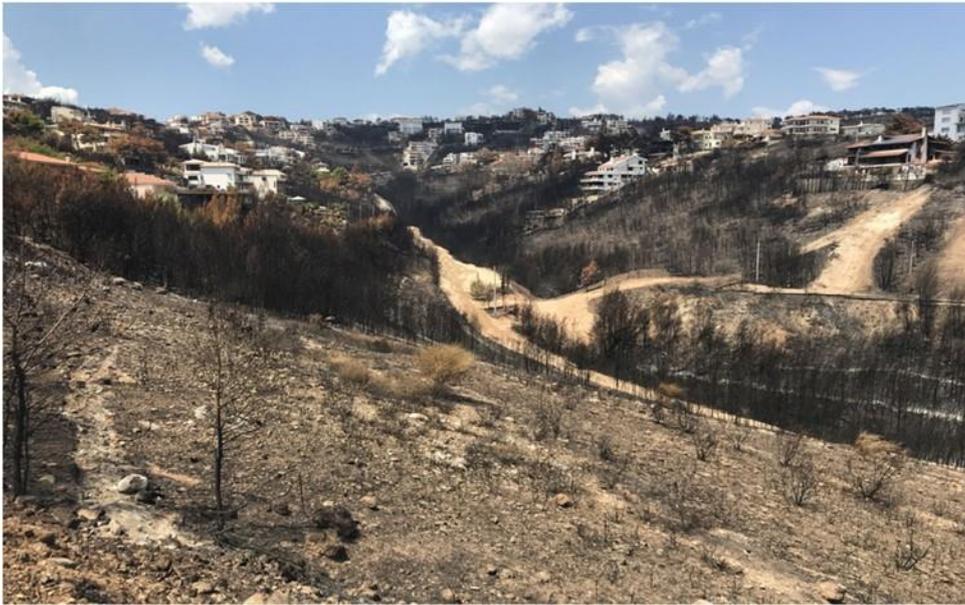
Figure 9-5. View of the aftermath in Neos Voutzas, looking West. Observe the intensity of some of the fire runs. In this area just few structures were destroyed, but many others were affected.

The fire front continued this intense run for about 1600 meters until hitting the first set of houses at the West limit of Neos Voutzas residential area around 17:30 h (that means, roughly speaking, two kilometres in 50 minutes rendering an average rate of spread of 40 m/min). Once there, the fire front progressed fiercely downslope through the different ravines within the settlement (Figure 9-4), mainly helped by the existing very dense and flammable pine stand and the channelling of the wind, creating tracks of propagation and secondary impacts with houses, roads and installations inside. Some houses were destroyed and many others were just affected (Figure 9-5).

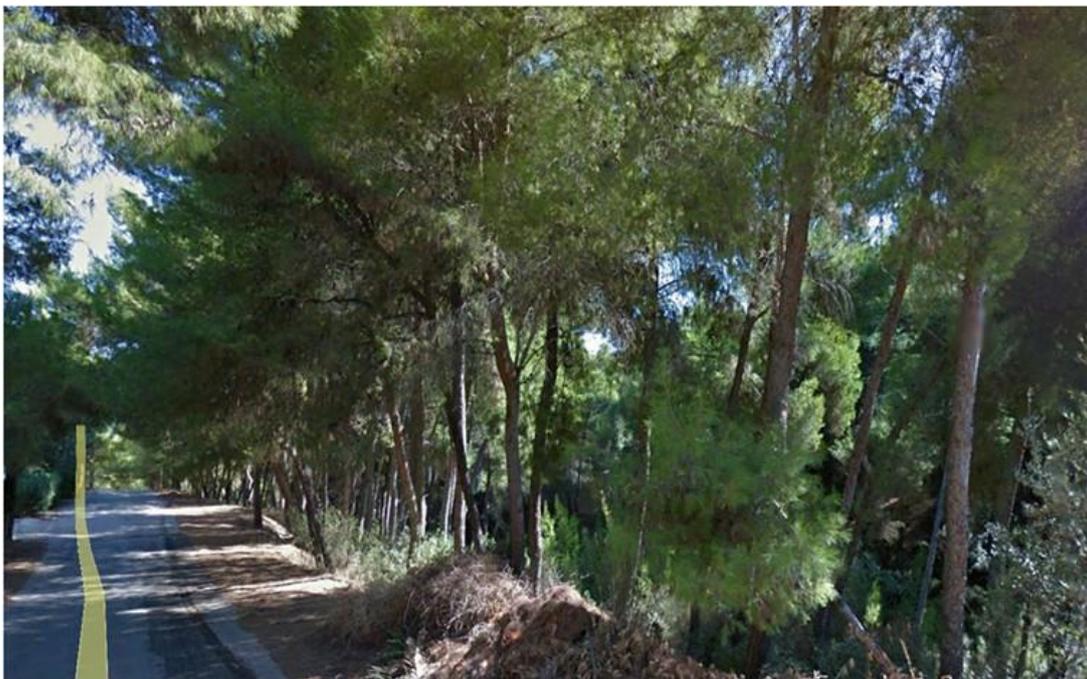
Figure 9-6. Street View from Google of one of the ravines within Neos Voutzas, packed with fuel in a dense pine stand. Observe the dead fine materials laying in the ground.

One of these fire runs continued steadily through the ravine in Ekavis street, building up the heat release and fire spread rate. Google Street View in such point depicts a remarkable accumulation of forest fuel and dead vegetation debris prior to the fire. At the end of the street another pine stand interlaced with dense shrub, placed in between Attalou Str. and Marathon Av., was in the trajectory of the fire head (Figure 9-6).

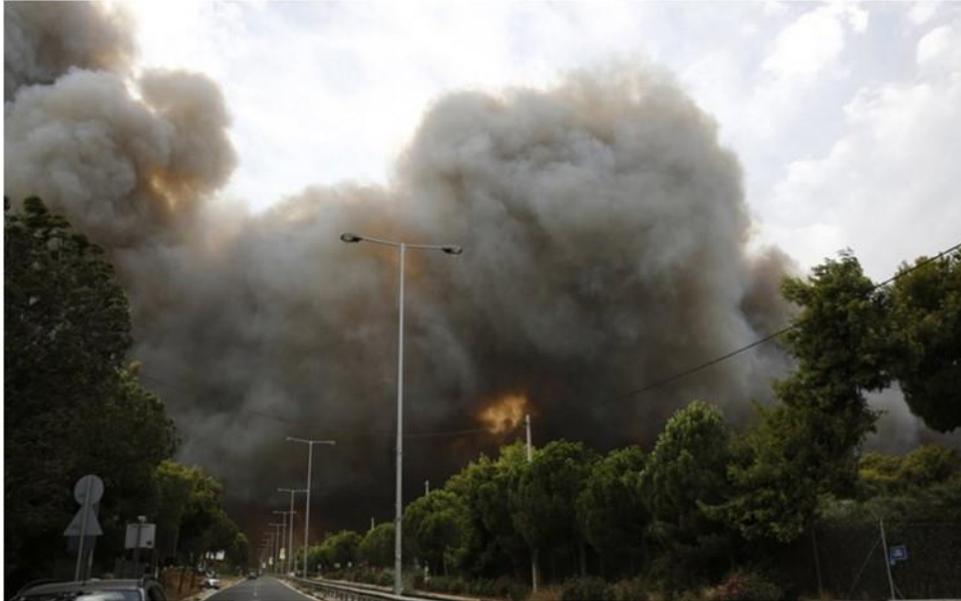
Figure 9-7. Moment in which the fire jumps from Neos Voutzas (to the right) into Mati area (to the left), strongly pushed by winds. Both sides presented dense pine stands. The traffic in Marathonos Avenue (depicted) was still present. Photo is taken looking South.

That dramatically helped in the new increase of fire activity, the production and projection of firebrands and, eventually, the fire jump into Mati area at around 18:10. This was the central, and most likely the first, entry point of fire into Mati.

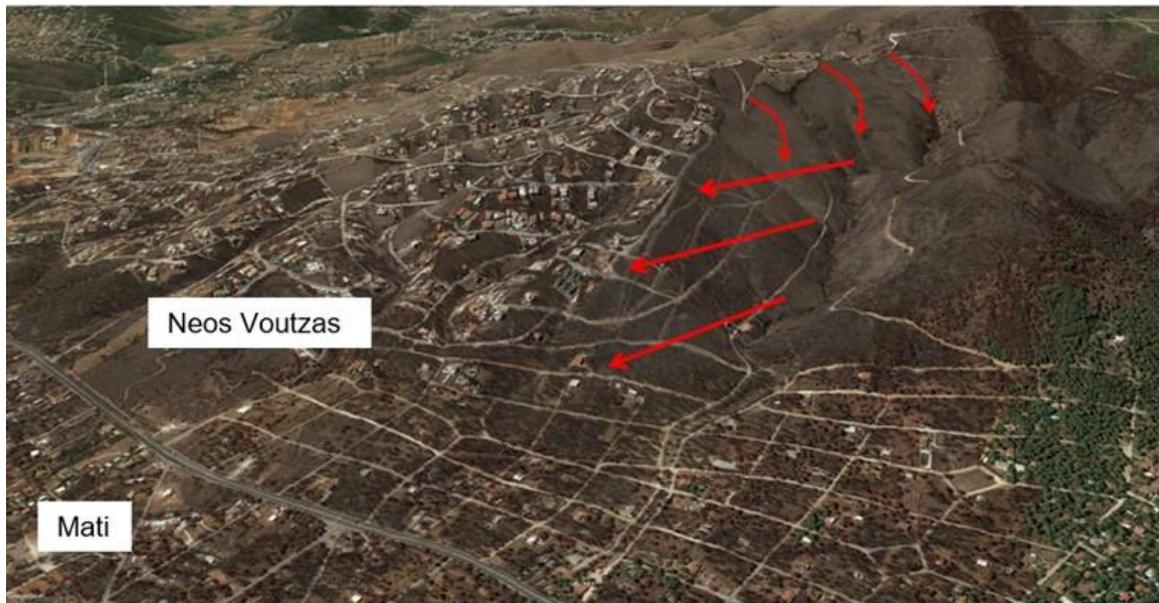
Figure 9-8. Progression of the left flank. The left flank slowly entered a deeper ravine at the North and slowly but steadily progressed downslope. The projection of firebrands created spot fires which eventually developed oblique topographic runs.

The left flank in Neos Voutzas had already opened and reached the base of another ravine, just by the foot of the slope leading to a set of isolated houses of the settlement and the Orthodox Childhood Village of Lireio Idruma, running up and causing the affectation and destruction of several buildings. Later on, by the time the fire head was nearly reaching Marathon Avenue in the central part (as deduced from pictures of that moment), the left flank in Neos Voutzas continued a slow but steady descent through a dense pine stand towards the canyon parallel to Manou Katraki Rd., with the main axis practically running in the same direction as the wind was blowing (Figure 9-8).

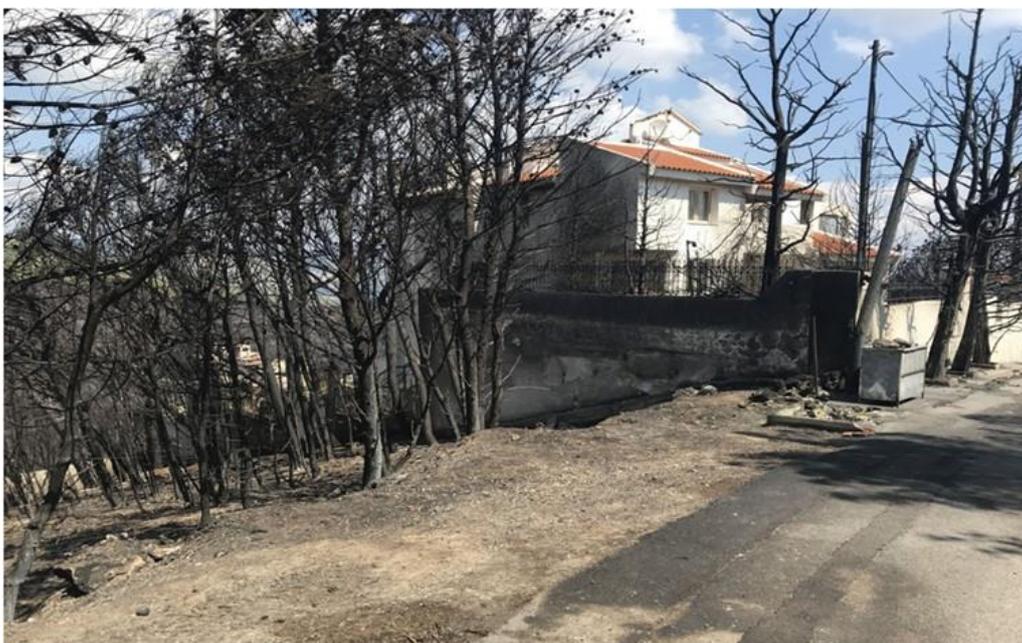
Figure 9-9. House impacted by fire in Neos Voutzas. Some of the houses receiving the impact of these oblique runs. One of them (close to the house depicted here) is Kostantinos Gkikas house, who managed to record a front progression with his cellular phone.

Several houses in that area were affected and some completely destroyed (Figure 9-9). As observed in some other video footage (i.e. Alpha Channel, recorded from km 14 of Marathon Av.), the fire was running fast and intense all the way down Manou Katraki, finding at the end a new area with dense pine stands mixed with some sparse housing just prior to the jump of flames over Marathon Av. into the North part of Mati area. As a conclusion, the fire created several entry points into the Mati area, with firebrands projection (seen in the video) and severe fire behaviour, widening the affection all across Marathon Avenue and reducing opportunities for a safe evacuation and fire suppression.

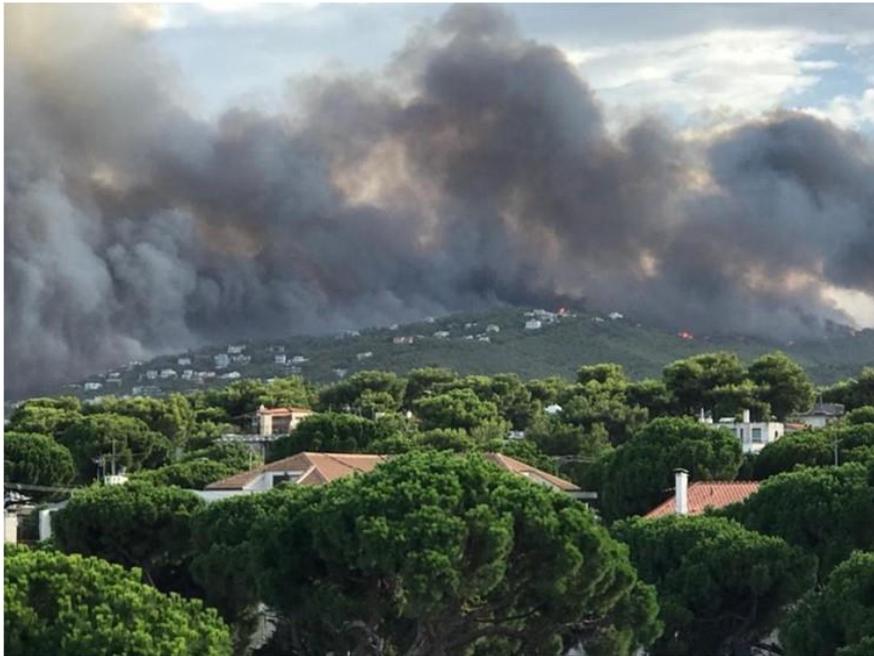
Figure 9-10. Left flank is ready to enter the ravine at North. Some spotting is observed which eventually gave intense runs upslope. The head has already progressed up to Marathon Avenue. Photo is taken looking South to Southwest.

The pictures gathered show a very intense fire and an almost horizontal smoke plume, a typical indicator of a wind-driven wildfire (Figure 9-10). The video footage (Alpha Channel) show a very active spotting fires inside Mati area, due to the shower of firebrands produced mainly in the pine stands near Marathon Avenue. Analysis of the aftermath orthophoto also indicates numerous spot fires, as several parts of vegetation were left unaltered.
