D3.3

Case studies – Issue 3

Instrument	Collaborative Project
Call / Topic	H2020-SEC-2016-2017/H2020-SEC-2016-2017-1
Project Title	Multi-Hazard Cooperative Management Tool for Data Exchange, Response Planning and Scenario Building
Project Number	740689
Project Acronym	HEIMDALL
Project Start Date	01/05/2017
Project Duration	42 months
Contributing WP	WP 3
Dissemination Level	PU
Contractual Delivery Date	M26
Actual Delivery Date	07/08/2019
Editor	Jordi Vendrell (PCF)
Contributors	David Martín, Sebastien Lahaye, Felipe Borderas, Oriol Vilalta (PCF), Daniel Milla, Laia Estivill, Edgar Nebot, Jordi Pagès (INT), Flavio Pignone (CIMA), Bruce Farquharson (SFRS), Sefik Muhic, Jesper Bachmann Marcussen (FBBR)

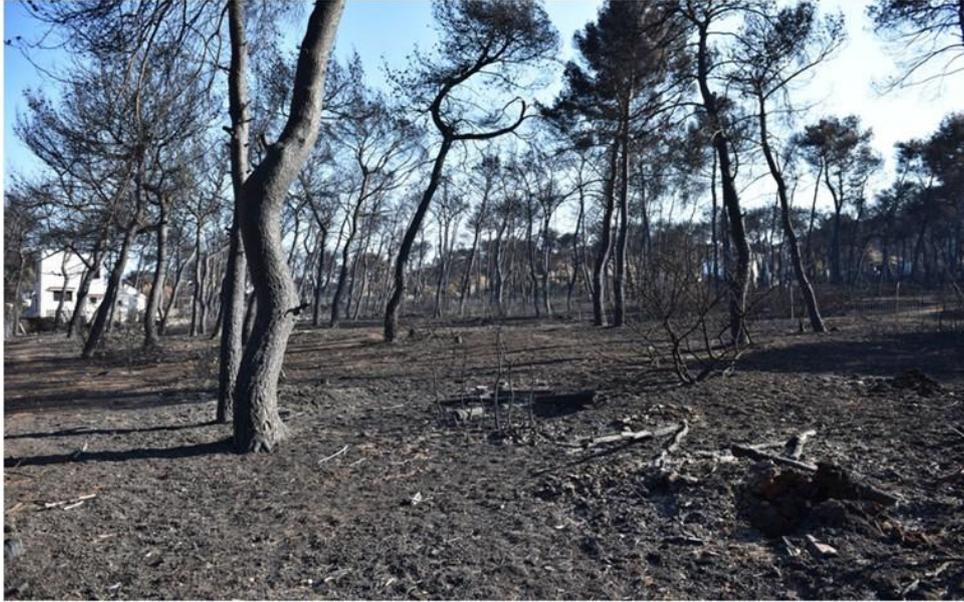
Figure 9-11. Fire progression inside Mati area. Spotting took place over dry fine fuels and quickly catching up surface fuels (the main fire carrier) and eventually pine crowns. The long plots helped in transferring the fire inside the settlement.

Once in Mati, a densely populated area intermixed with a pine stand, the fire found plenty of available fuel in the long and narrow lots as a result of a continuous, persistent lack of management over the years, particularly in the undeveloped lots. This fact was particularly notorious in the central part of Mati, near Marathon Avenue, where the first fire jump most likely took place. Indeed, it seems that the long plot of pine stand (350x110 m²), located between Pefkalis and Akropoleos streets, played a prominent role in transferring an intense fire propagation (particularly in the first 200 m), and entailing the destruction of the houses placed on both sides.

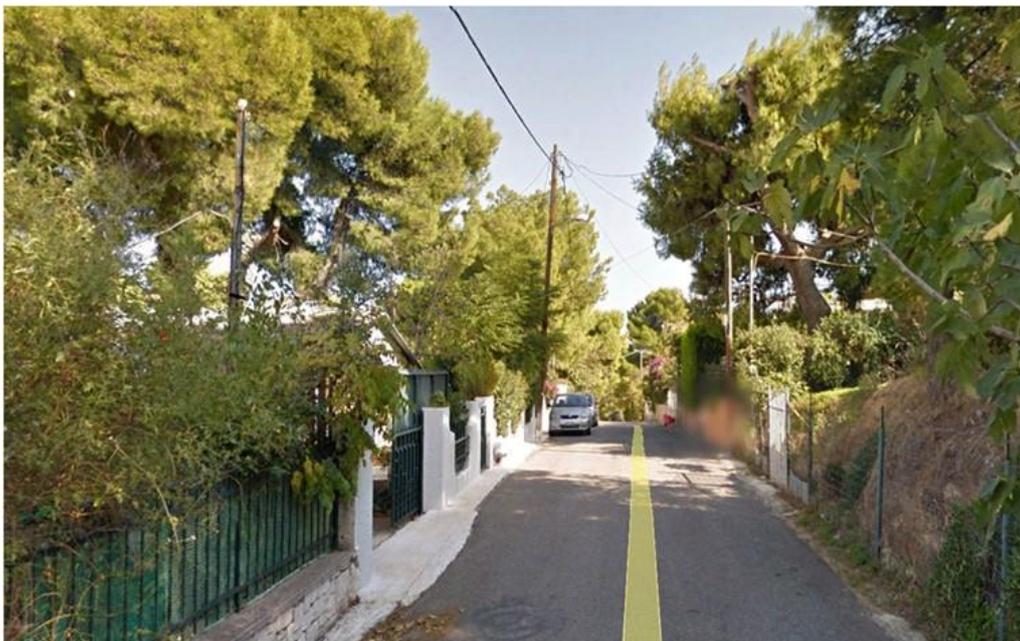
Figure 9-12. View from inside Mati prior to the fire. Narrow streets, remarkable fuel load both sides and vegetal debris, amongst other factors, contributed to the rapid spread of the fire. Most likely, many fire outbreaks progressed and interacted inside the settlement.

A visual analysis on Google Street View -courtesy of Google- of the situation previous to the fire makes it patently clear the fuel buildup, particularly dead fine fuels, the continuity of such fuel bed, the presence of ladder vegetation, the overall accumulation of vegetal debris – resulting from the gardening activity-, and the abandonment of all types of objects (even old cars) (Figure 9-12). This all generates a fuel structure ready to receive firebrands, generate spot fires, produce flashy and highly energetic runs, entail crown fires, and eventually cause the destruction of houses.

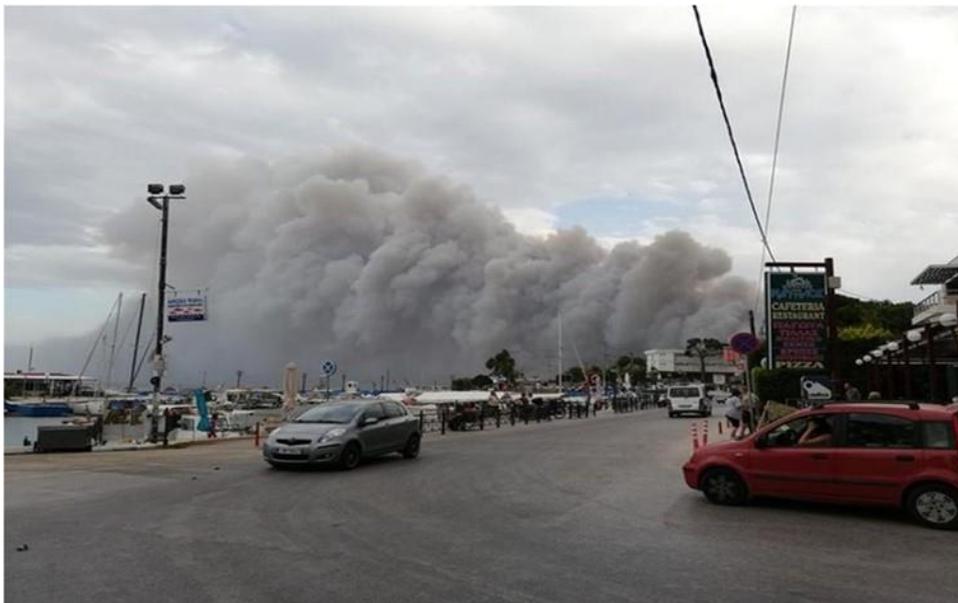
Figure 9-13. View from Nea Makri port. The image shows a dramatically tilted smoke plume, dominating the low atmosphere of Mati area. Photo is taken looking South.

As observed in pictures of that moment, and according to testimonies gathered from survivors, the last run of the fire front was very quick and destructive. The nearly one kilometre that goes from Marathon Av. to the coast was covered in about 15 minutes. Several pictures of the moment show that the smoke plume stayed mostly attached to the ground, creating what was looking as a 'pyroclastic flow', as referred to by some firefighters (Figure 9-13). In fact, the analysis of the aftermath orthophoto shows clear indications of massive production of firebrands, the setting of numerous spot fires, which eventually interacted between them and increased the overall rate of spread (when compared with a regular frontal spread rate of fire).

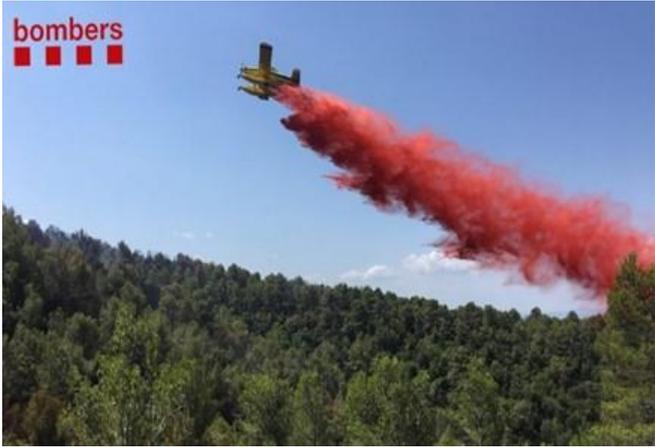
<p>The image shows a bomber aircraft in flight, releasing a thick stream of red fire retardant over a dense green forest. In the top left corner, there is a logo with the word "bombers" in red and four red squares below it.</p>	<p>Retardant dropping operations from an aircraft of the Fire Service of the Government of Catalonia.</p>

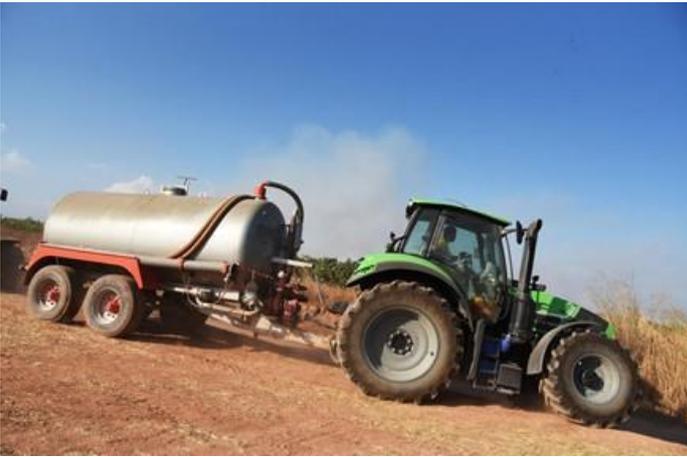
<p>A green tractor is pulling a large silver water tank on a dirt road. The scene is outdoors under a clear blue sky.</p>	<p>Heavy machinery assisting in suppression tasks.</p>

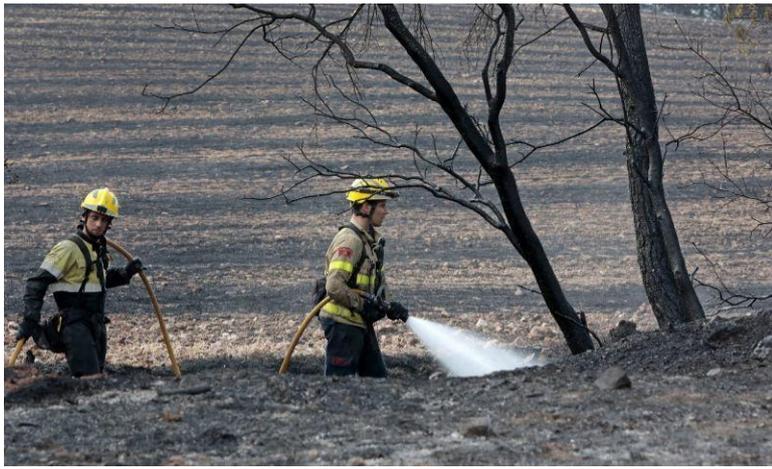
Firefighters of the Fire and Rescue Service of the Government of Catalonia extinguishing hot spots.
